A Rare Journey of a Contraceptive Implant Migrating to the Proximal Humerus: A Case Report from Oman

DOI 10.5001/omj.2028.14

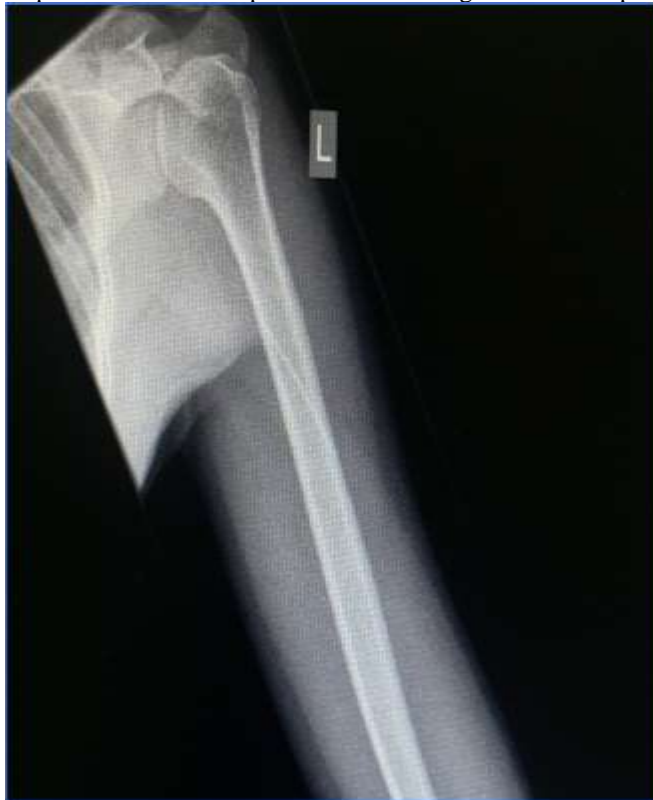
Figure 1: X-ray of the left upper arm and shoulder of a 29-year-old female showing migration of a contraceptive implant to the medial aspect of the proximal humerus.

A 29-year-old female with no past medical history presented to the birth spacing clinic at Seeb Health Center, a primary health care facility in Muscat, Oman, on April 27th, 2023. She sought the removal of her Implanon-NXT® implant, which had been inserted in her left arm on December 31st, 2020, as she wished to conceive. During the clinical assessment, the implant was found to be non-palpable at the expected insertion site. Upon local examination of the left arm, a foreign body was palpated on the medial aspect of the proximal humerus, without any overlying skin changes or swelling. X-ray imaging of the left arm confirmed the proximal and deep displacement of the Implanon-NXT® along the medial aspect of the proximal humerus [Figure 1].

the biceps muscle, near the ulnar nerve below the deep fascia, adjacent to the median nerve, and in rare cases, even within the pulmonary artery.^{4,9} Although the latter situation is rare, it can be a life-threatening event necessitating immediate medical attention.⁴ In the present case, the implant migrated to the medial aspect of the proximal humerus, as confirmed through X-ray imaging, with surgical intervention required for removal.
